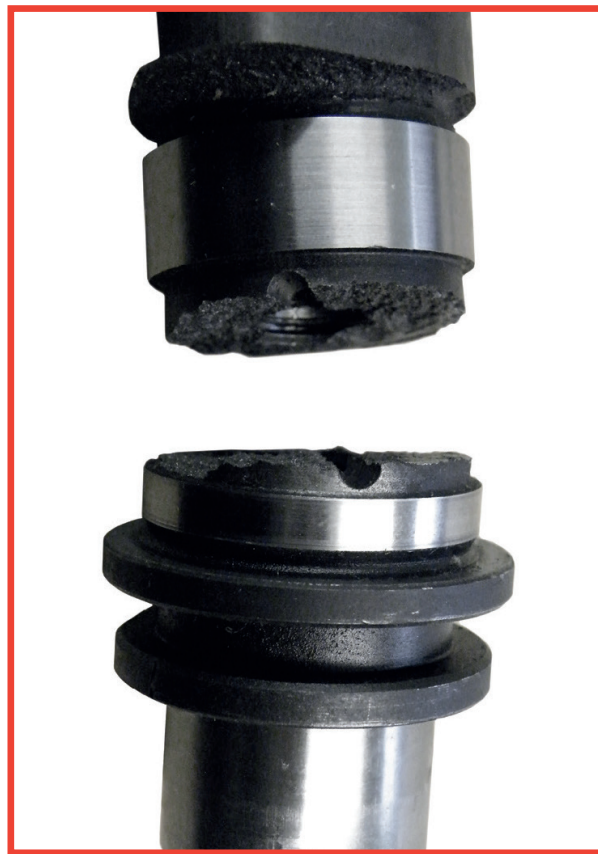
Broken camshaft

Appearance: Camshaft breakage between or through cam-lobes.
Causes: Distorted camshaft housing or cylinder head. Incorrect torque sequence and mishandling can also cause similar breakage.
Remedy: Straighten or replace camshaft carrier/cylinder head, use correct bolt torque sequence and handle with care. Thoroughly flush the lubricating system, replace cam and followers, prime with extreme pressure lubricant and replace oil and oil filter.

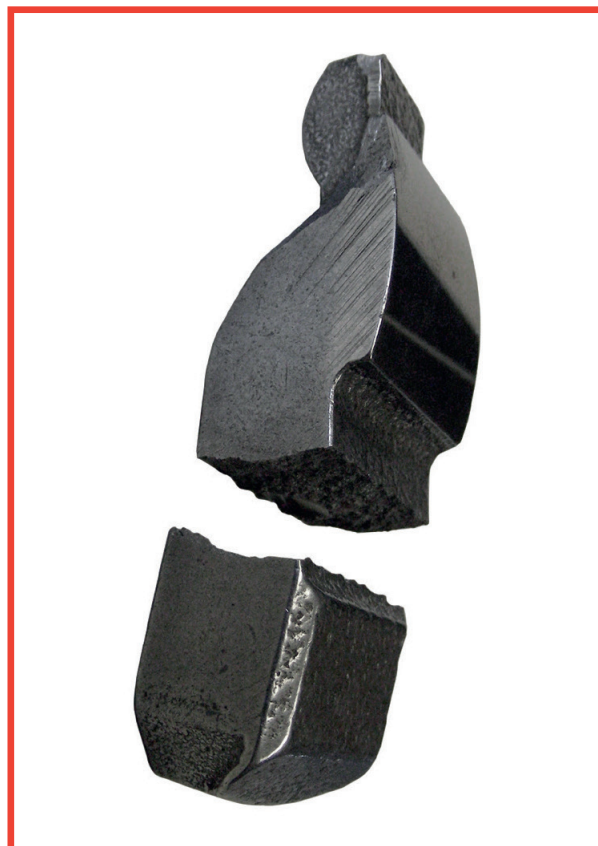
Follower breakage

Causes: Mechanical overload resulting from:
1 Sticking or seized valve, resulting in the follower to break due to cam-lobe pressure.
2 Piston contact with the valve due to:
 a Weak valve spring
 b Over extended hydraulic lifter
 c Incorrect assembly of valve tip-cap
 d Timing belt breakage
 e Or through over high revving of engine.
3 Incorrect valve timing.

Remedy: Investigate & rectify the mechanical overload cause. Thoroughly flush the lubricating system, replace all damage components, prime cam and followers, with extreme pressure lubricant and replace oil and oil filter.

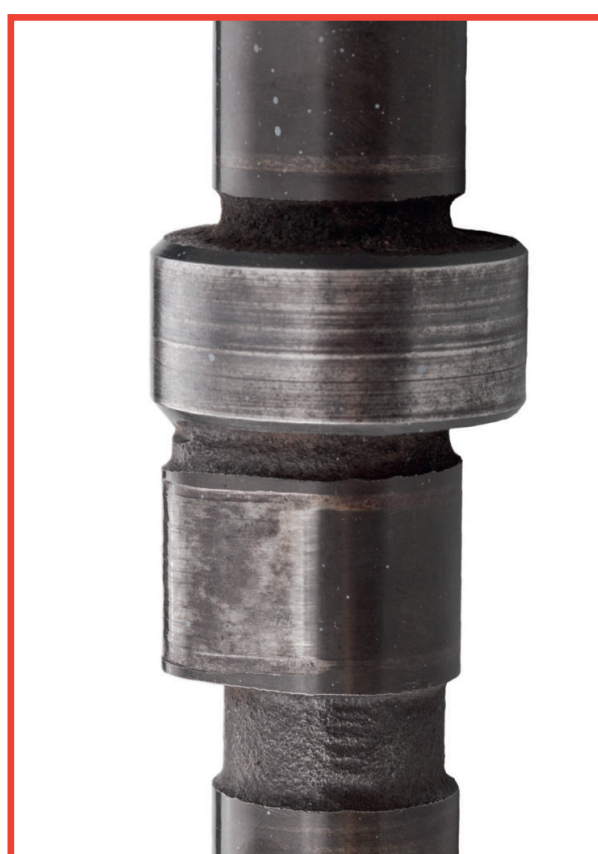
Excessive cam-lobe wear

Appearance: Severe cam-lobe wear.
Causes: Starvation or contamination of oil, tappet clearance too tight, excessive valve spring pressure.
Remedy: Thoroughly flush the lubrication system, install new camshaft and followers. Adjust tappets to the correct clearances, prime with extreme pressure lubricant and replace oil and oil filter.

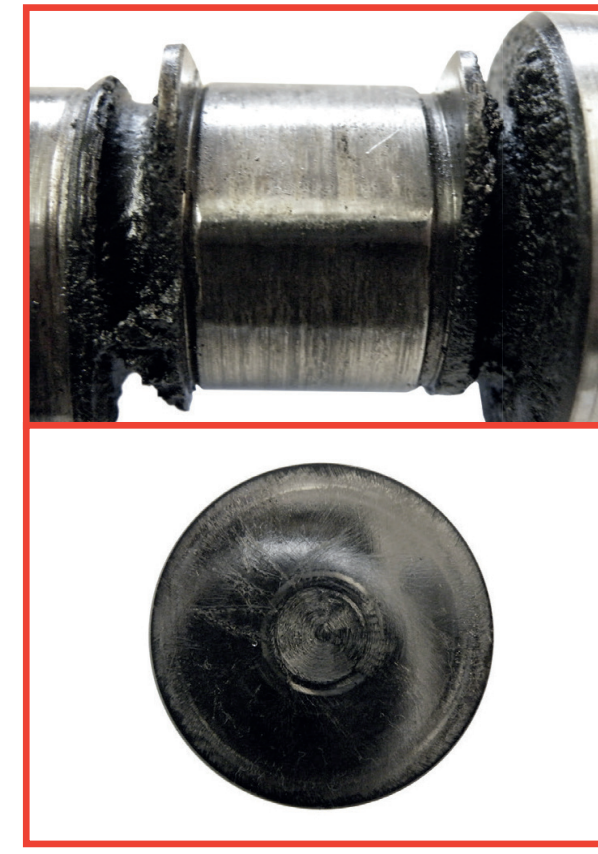
Cam-lobe and follower wear

Appearance: Premature wear of one or more cam-lobes & followers. Follower contact surface will be concaved with chipped edges.
Causes: Incompatible cam-lobe & follower contact surface geometry. Often caused by fitting new camshaft with old followers or vice versa. Can also result from lubricant starvation from blocked or restriction in oil supply.
Remedy: Thoroughly flush the lubricating system, replace cam and followers, prime with extreme pressure lubricant and replace oil and oil filter. Do not mix old and new components.

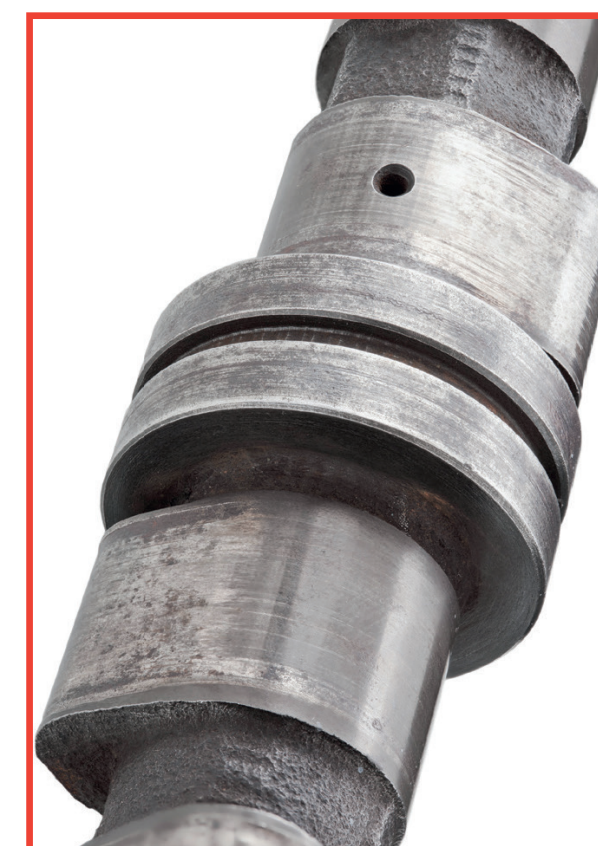
'Scored' bearings

Appearance: Severe scoring of the camshaft bearings.
Causes: Starvation or contamination of oil, i.e. foreign particles circulating in oil.
Remedy: Thoroughly flush the lubricating system, replace cam and followers, prime with extreme pressure lubricant and replace oil and oil filter.

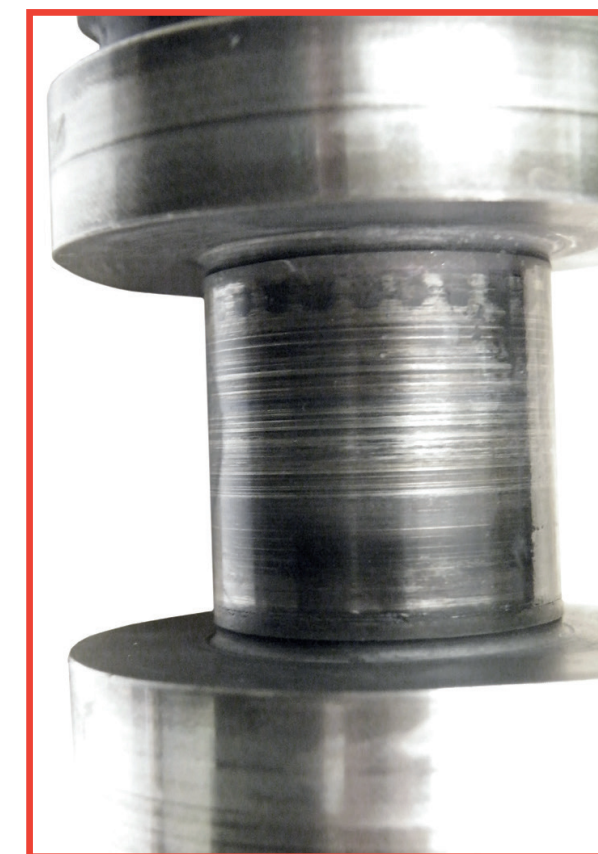
Overheated camshaft

Appearance: Cam-lobes, bearings & followers have a 'blue' discoloration.
Causes: Overheated engine possibly due to cooling failure.
Remedy: Investigate and rectify the cause of the overheating. Thoroughly flush the lubricating system, replace cam and followers, prime with extreme pressure lubricant and replace oil and oil filter.

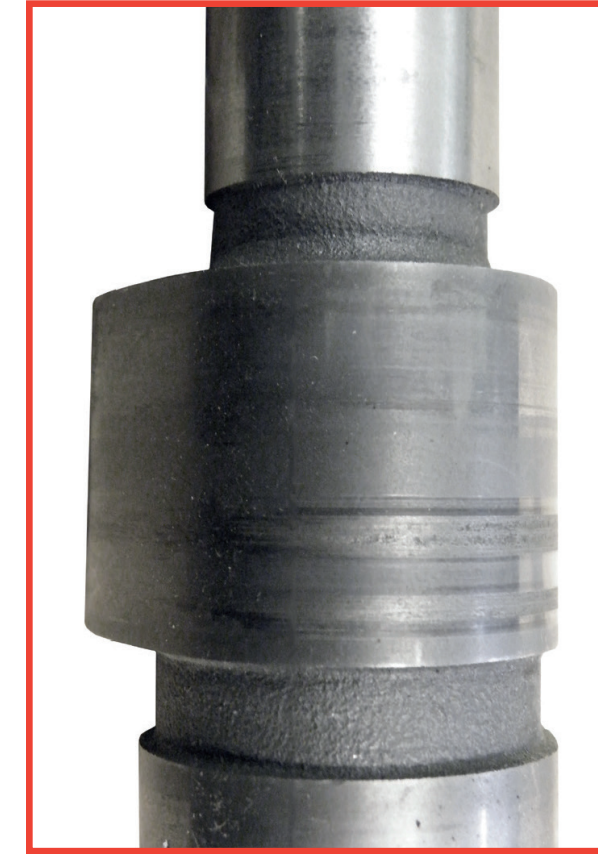
Base circle contact marking

Appearance: Witness marking on base circle of cam-lobes, biased to one side.
Causes: Worn hydraulic lifter and/or retainer springs.
Remedy: Replace cam and followers if marks are deep, otherwise set tappets to correct clearance. Thoroughly flush the lubricating system and replace oil and filter.

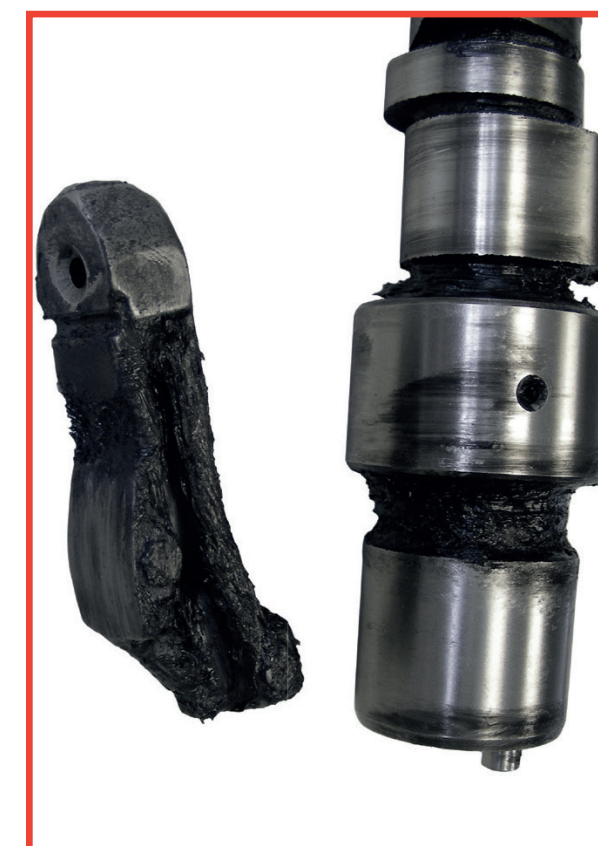
Carbonised oil deposits

Appearance: Carbonised oil build-up on cam and followers.
Causes: Excessive operating temperatures resulting from marginal lubrication conditions due to contaminated lubricating oil or blockages/restrictions in oil feed galleries.
Remedy: Thoroughly flush the lubrication system, ensuring that all galleries and hydraulic lifters (where fitted) are free from blockages & debris. Install new camshaft and followers, prime with extreme pressure lubricant and replace oil and oil filter.

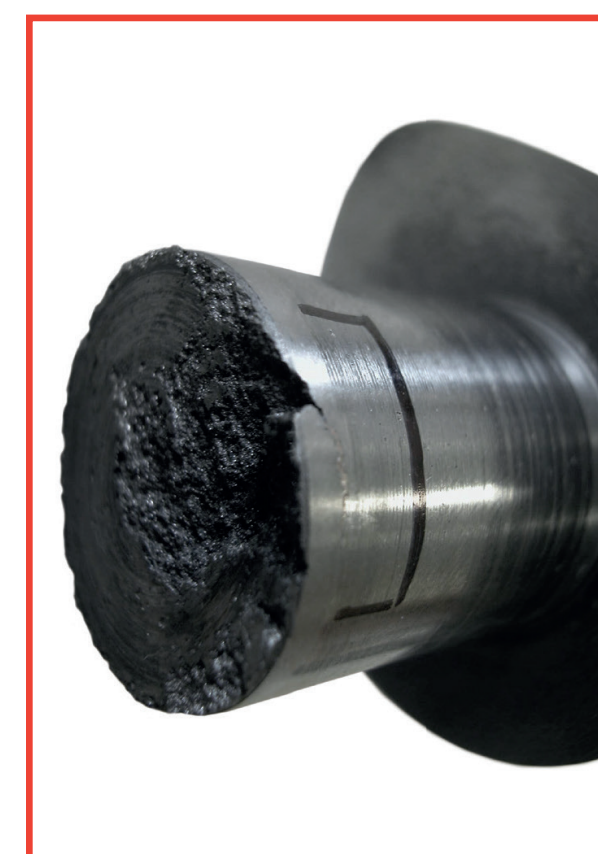
Physical damage to camshaft & followers

Appearance: Cam-lobes, bearings & followers "chipped".
Causes: Excessive end-float due to:
 a Worn thrust washer
 b Loose distributor
 c Worn distributor drive gear
 d Or misaligned timing gears
Remedy: Investigate and rectify the cause of the damage. Thoroughly flush the lubricating system, replace cam and followers, prime with extreme pressure lubricant and replace oil and oil filter.
