VALVE OPERATING CONDITIONS

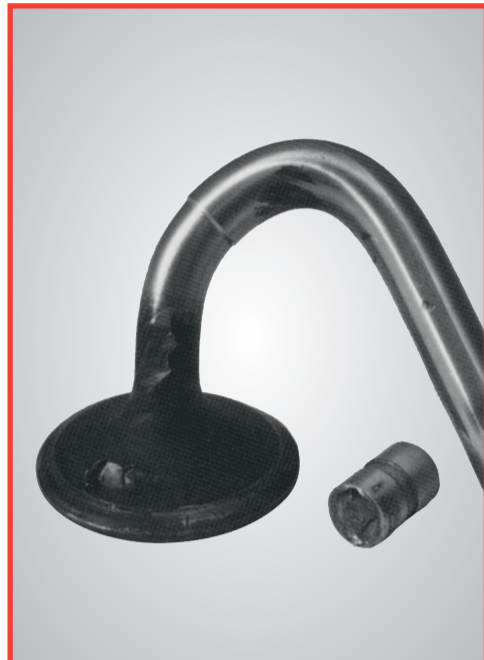
Stem breakage through collet groove

Symptom: Excessive mechanical noise, bent stem and possible head detachment.
Cause: Poor assembly allowing uneven loading. Poor handling, dropping etc. Bouncing the valve after fitting by hitting the tip with a hammer. Valve bounce from excessive seating velocity.
Remedy: May not be possible due to extreme damage this failure can cause, however: Check seats, guides, springs, pistons and bores for damage and repair where necessary. Do not overspeed the engine.

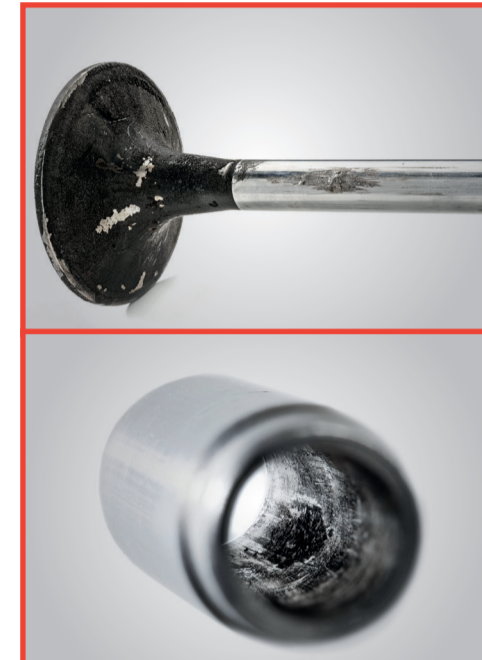
Scuffed/sticking valve stem

Symptom: Poor performance due to low compression. Mechanical breakage due to sticking valves.
Cause: Marginal lubrication from inadequate valve to stem clearance, causing scuffing or metal transfer. This may ream out the valve guide leading to the second cause, excessive oil from too great a clearance carbonising on the stem to cause sticking.
Remedy: Ensure the valve stem to guide clearance is to specification. Ensure the correct valve stem seals have been used. Replace worn components where necessary.

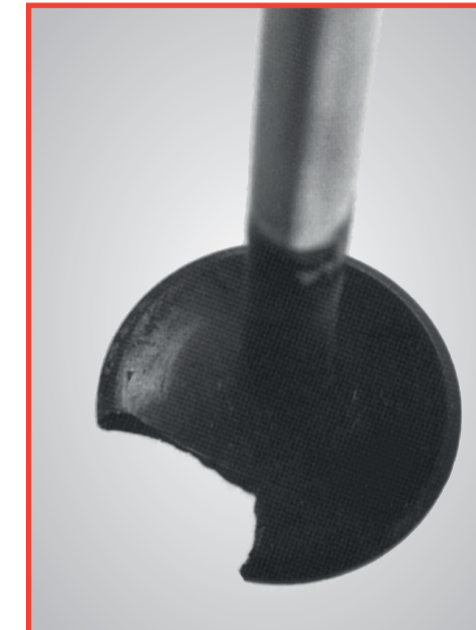
Radial cracking of valve head, leading to a triangular segment breaking off

Symptom: Sudden mechanical noise. Rough running. Possible seizure.
Cause: Poor temperature distribution across the valve head resulting in high tensile stresses in the rim, often combined with severe deflection due to abnormal combustion pressures and temperatures. Extreme thermal cycles, (continual sudden changing from full power to shut-down). Damage marks on the rim producing stress raisers. Mechanical overload from valve bounce.
Remedy: Check the remaining valves for signs of cracking, replace where necessary. Ensure the correct valves have been used. Check engine settings, valve springs, guides and followers. Do not overspeed the engine.

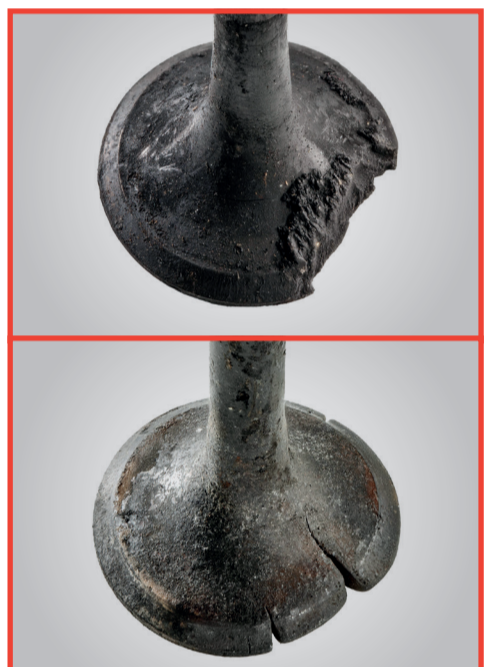
“Gutter“ burnt through valve rim

Symptom: Loss of power. Rough running.
Cause: Valve clearance too small holding the valve off its seat. Sticking stem, poor/uneven seating or misalignment of the valve assembly. Overheating from pre-ignition. Excessive build up of carbon which flakes off the valve face to form a gas leakage path. Hard carbon particles peen into the seat surface until enough indentations line up to form a gas leakage path.
Remedy: Ensure valve clearance is to specification. Check stem to guide clearance and for any misalignment of the valve assembly. Check engine timing, carburettor settings and injection timing.

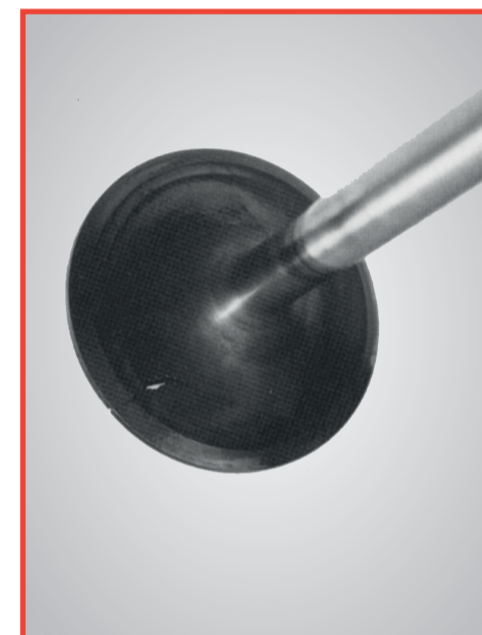
Blow hole through valve head, starting from a radial crack

Symptom: Rough running. Loss of compression. Poor starting.
Cause: Similar to a segmental breakage, but gas escapes through the crack and burns a hole. Extreme thermal cycles (continual sudden changing from full power to shut down). Damage marks on the rim producing stress raisers. Mechanical overload from valve bounce.
Remedy: Check remaining valves for signs of cracking, replace where necessary. Ensure the correct valves have been used. Check engine settings, valve springs, guides and followers. Do not overspeed engine.

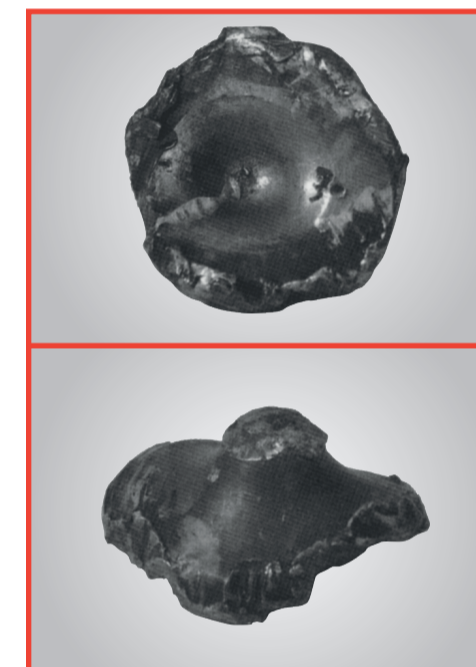
Valve head breaking off stem

Symptom: Rough engine with sudden mechanical noise.
Cause: Mechanical overload, such as seating velocity too high from excessive valve clearances. Valve bounce, valve to piston contact caused by overspeeding, weak or broken valve springs or sticking valve stem. Uneven seating due to misalignment or distorted valve.
Remedy: May not be possible due to extreme damage this failure can cause, however: Check valve springs, guides and alignment and repair where necessary. Check seat guides, pistons and bores for damage. Reset the valve clearances.

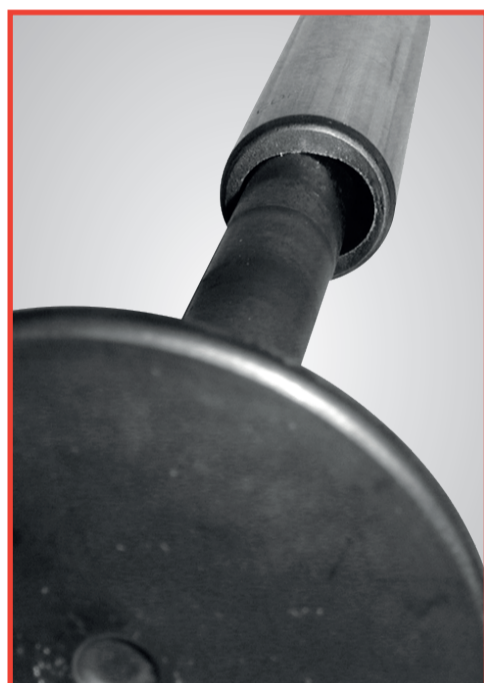
Excessive valve stem and guide wear

Symptom: Valve gear noise, high oil consumption, exhaust smoke on initial start up.
Cause: Too great or too small valve stem to guide clearance. Poor valve stem lubrication or ingress of dirt through the air intake system. It should be noted that the cause of this problem is not always obvious. Unless the cause is readily apparent, additional advice should be sought.
Remedy: Ensure correct valve and guides are fitted. Check alignment, valve stem to guide clearances, valve stem seals and lubrication system.

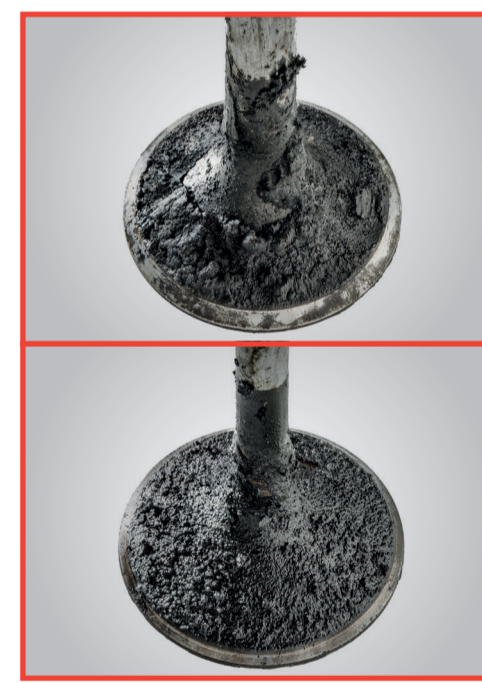
Inlet valve underhead carbon build-up

Symptom: Poor starting. Loss of power. Blue smoke from exhaust (when throttle closed).
Cause: Excessive clearance between valve stem and guide. Valve stem seal failure or wear. Excessive oil supply due to blocked drainage paths. Incorrect grade of lubricating oil used.
Remedy: Check valve stems, guides and stem seals for wear and replace where necessary. Ensure there is no blockage in the engine drainage or breathing systems.

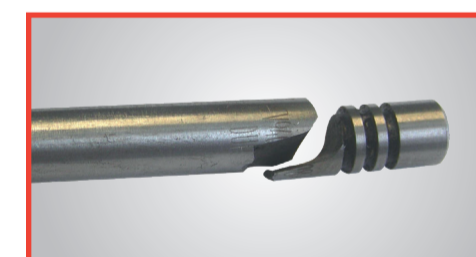
Valve breakages – fracture at lower cotter groove

Symptom: Valve breakage shortly after cylinder head rebuild, during initial start-up or during test run.
Cause: Over extension / “pump-up” of hydraulic lifters (photo 1). Incorrect seating of the valve spring to the head (photo 2). Engine over-speed or weak springs.
Remedy: Where possible fit new hydraulic lifters with new valves. Ensure the engine block is thoroughly cleaned to remove all traces of debris. Take extreme care to seat all valve springs correctly in the recess of the cylinder head. Renew engine oil and replace oil and air filters.

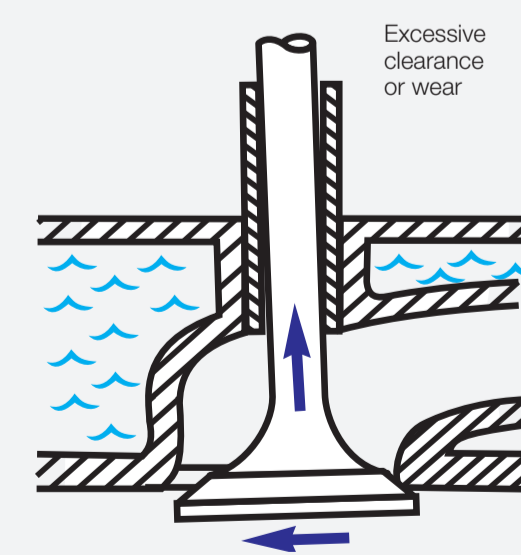
- The valve seat must be concentric with the valve guide. Any eccentricity that exists between the valve seat and guide will force the valve sideways.
- Excessive valve guide wear will occur as a result of this which can lead to a fatigue failure of the valve stem.
