Diesel Engine Oil Consumption

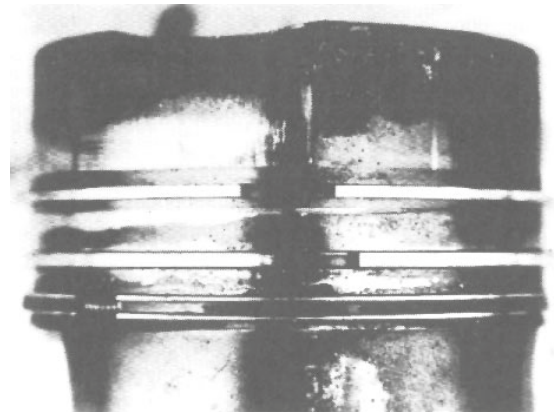
Fig. 1

Cylinder bore polishing arises from the excessive deposits of hard carbon on the piston top land (**Fig. 1**). Bore polishing tends to be self-evident. It is characterised by a bright, smooth "mirror-like" surface with elimination of the crosshatch-honing pattern (**Fig. 2**). The photographs show a cylinder liner and its mating piston, vividly illustrating the bore polishing condition present on the thrust faces.

The S.H.P.D. Oils previously mentioned and available from major oil companies are to be recommended for their ability to prevent cylinder bore polishing and show significant oil control advantage.
