Diesel Engine Oil Consumption

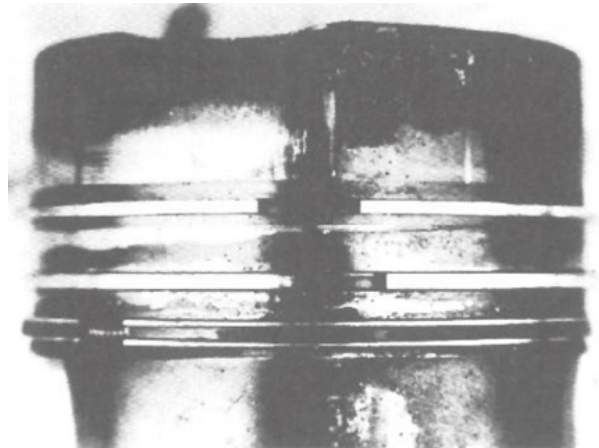
Fig. 1

Turbocharged engines operating at high ratings may give rise to a bore polishing condition. Inlet air temperatures are high and tests have shown that surface temperatures are a major factor in the formation of a polish. Prolonged operation on a well-known turbo engine tested at 355 HP resulted in 5% of the bore area exhibiting a polish; raising the power to 360 HP increased the polish area to 14% in the same time period.

Fig.1 Cylinder bore polishing arises from the excessive deposits of hard carbon on the piston top land (Fig. 1). Bore polishing tends to be self-evident. It is characterised by a bright, smooth "mirror-like" surface with elimination of the crosshatch-honing pattern (Fig. 2). The photographs show a cylinder liner and its mating piston, vividly illustrating the bore polishing condition present on the thrust faces.

The S.H.P.D. Oils previously mentioned and available from major oil companies are to be recommended for their ability to prevent cylinder bore polishing and show significant oil control advantage.
