VALVE OPERATING CONDITIONS

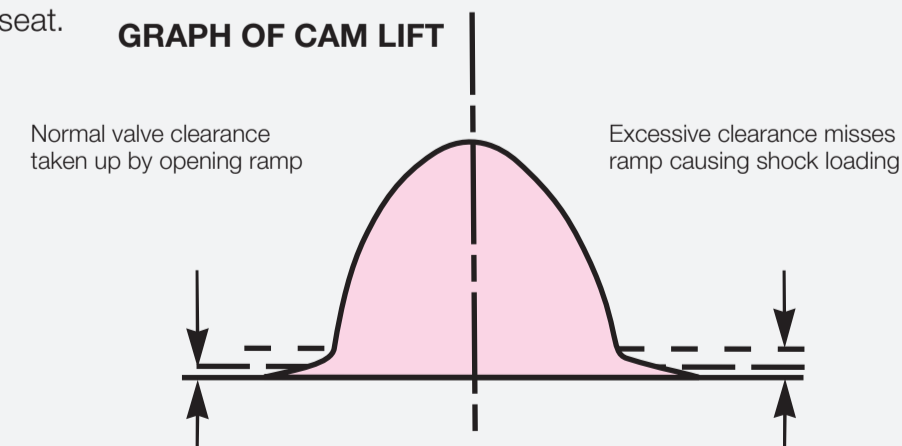
- Initial valve opening and final valve closing occurs very gently. Cam lobe profiles include lifting and lowering ramps to achieve this.
- Ensure the valve clearances are not too great to prevent the valve being hammered open or dropped onto its seat.
