Diesel Engine Oil Consumption

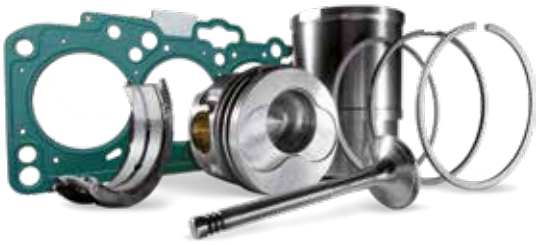
Turbocharged engines operating at high ratings may give rise to a bore polishing condition. Inlet air temperatures are of high magnitude and tests have shown that surface temperatures are a major factor in the polish formation. Prolonged operation on a well known turbo engine tested at 355 HP resulted in 5% of the bore area exhibiting a polish; raising the power to 360 HP increased the polish area to 14% in the same time period.

Cylinder bore polishing arises from the excessive deposits of hard carbon on the piston top land (**Fig. 1**). Bore polishing tends to be self-evident. It is characterised by a bright, smooth "mirror-like" surface with elimination of the crosshatch-honing pattern (**Fig. 2**). The photographs show a cylinder liner and its mating piston, vividly illustrating the bore polishing condition present on the thrust faces.

The S.H.P.D. Oils previously mentioned and available from major oil companies are to be recommended for their ability to prevent cylinder bore polishing and show significant oil control advantage.
